**ASSESSMENT OF MORPHOLOGICAL CHANGES OF RIVER BANK USING  
REMOTE SENSING AND GEOLOGICAL INFORMATION SYSTEMS, A CASE  
STUDY OF RED RIVER IN HANOI AREA.**

*This paper presents research results on river morphology by remote sensing data analysis, comparing and verifying with real observation result and some existing maps (topographic maps, land use map, ...). The results show that phenomenon deposition varies the year and the different stages of a year. Period 1996 - 2003, deposition area was 26.3 km<sup>2</sup>, located along the right bank in Ba Vi district, north of Dan Phuong district, northern of Me Linh district, Dong Anh district, metropolitan area; erosion area was 11.7 km<sup>2</sup>, in Vinh Phuc, opposite Ba Vi district, Phuc Tho district and south of Me Linh district. From 2003 to 2011, deposition area was 11.2 km<sup>2</sup>, distributed mainly in the riverbank of Vinh Phuc Province, Phuc Tho district and south of Me Linh district; erosion area was 23.8 km<sup>2</sup> from Ba Vi district to inner city. From 2011 to 2013, siltation occurred weakly, around 0.6 km<sup>2</sup>; erosion occurred sharply at the left bank of Ba Vi and Phuc Tho, Dan Phuong, Thanh Tri with an

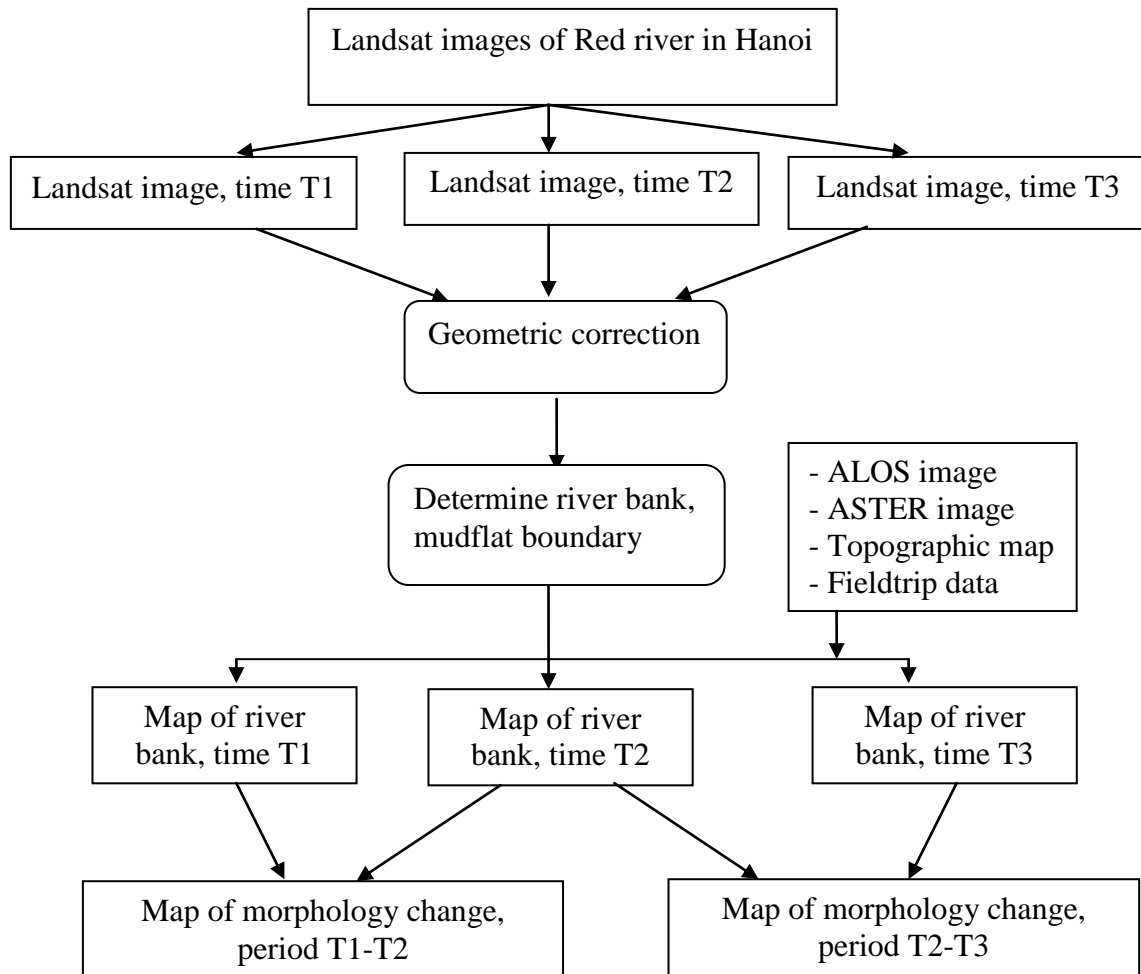
**Figure 1. Flowchart of creating morphology change map of Red river bank in Hanoi**

Flowchart of creating morphology change map is showed below (Figure 1):

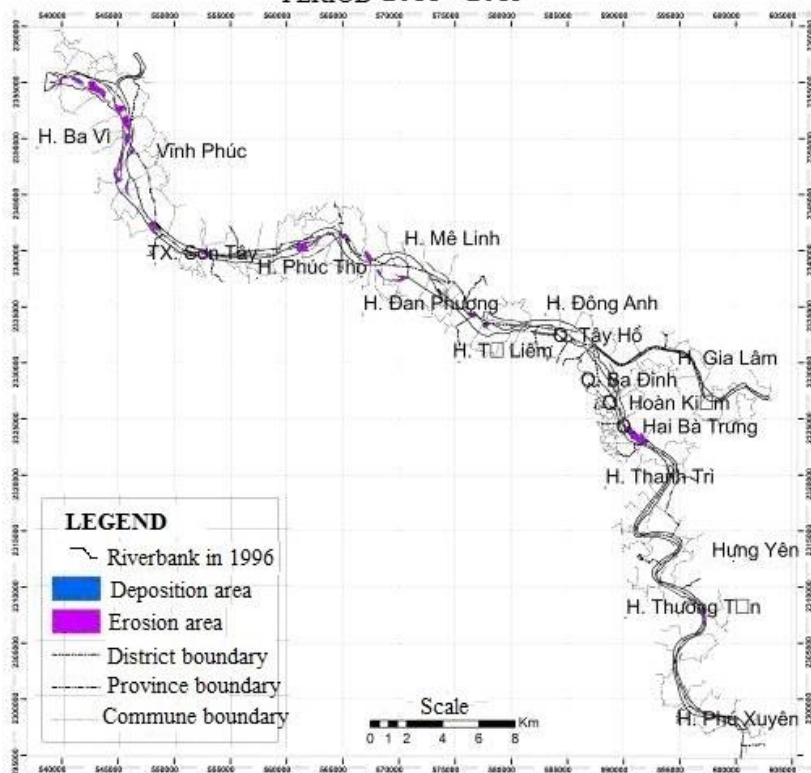
**Figure 5: Map of erosion, deposition in Red river bank, Hanoi area, period 2011 – 2013**

MAP OF EROSION, DEPOSITION IN RED RIVER BANK, HANOI AREA  
PERIOD 2011 - 2013

The morphological changes map of Red river in Hanoi (VN2000 projection) are showed in Figure 3, 4, and 5.

- *Period 2011 – 2013*: Siltation occurred weakly, approximately 0.6 km<sup>2</sup>; erosion occurred sharply at the left bank of Ba Vi and Phuc Tho, Dan Phuong, Thanh Tri with an area of 14.8 km<sup>2</sup>.

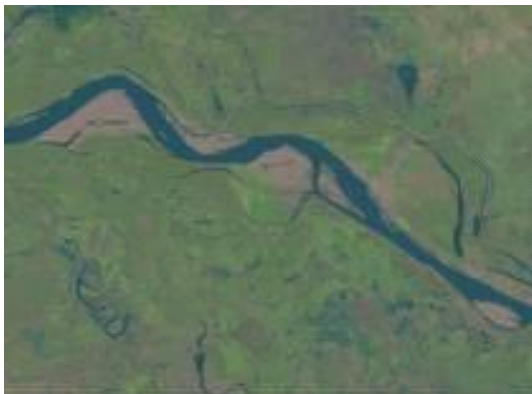
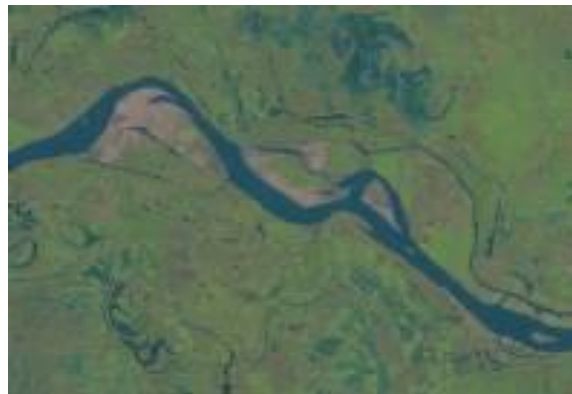
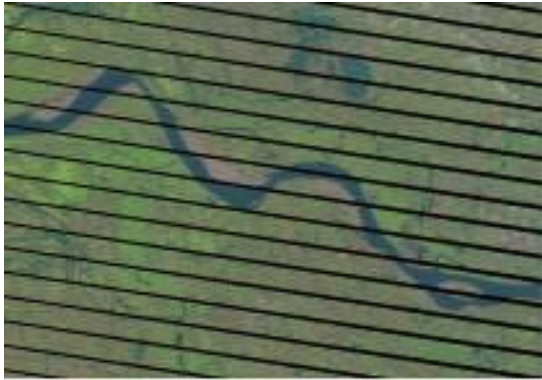
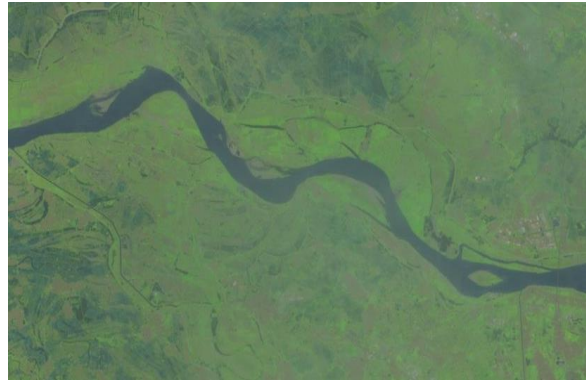
**Figure 6: Red river in Phuc Tho, Dan Phuong, Me Linh district**

Year 1996

Year 2003

Year 2011

Year 2013

The primary data were used TM, ETM+ sensor of Landsat satellite and Landsat 8 for four different years: 2/01/1996, 13/01/2003), 19/11/2011 and 9/6/2013 (Figure 6). The 2013 image is for a different periods and river bank change may reflect some seasonal effect. Recent change for the same period (Nov-Feb) as other satellite images will be verified as new satellite becomes available. Moreover, ASTER image, ALOS image, fieldwork data, topographic map were used as additional data.

- *Period 2003 – 2011*: deposition area was 11,2 km<sup>2</sup>, distributed mainly in the riverbank of Vinh Phuc Province, Phuc Tho district and south of Me Linh district; erosion process occurred strongly with 23,8 km<sup>2</sup> from Ba Vi district to inner city. Deposition and erosion processes led to channel movement in Phuc Tho, Me Linh and Dan Phuong. (Figure 6).
